**IGLOO AND REVETMENT
TESTS**

NAVAL PROVING GROUND, ARCO, IDAHO

OCTOBER, 1946

Army-Navy Explosives Safety Board 2029 Tempo 2 Building
Washington, D. C.

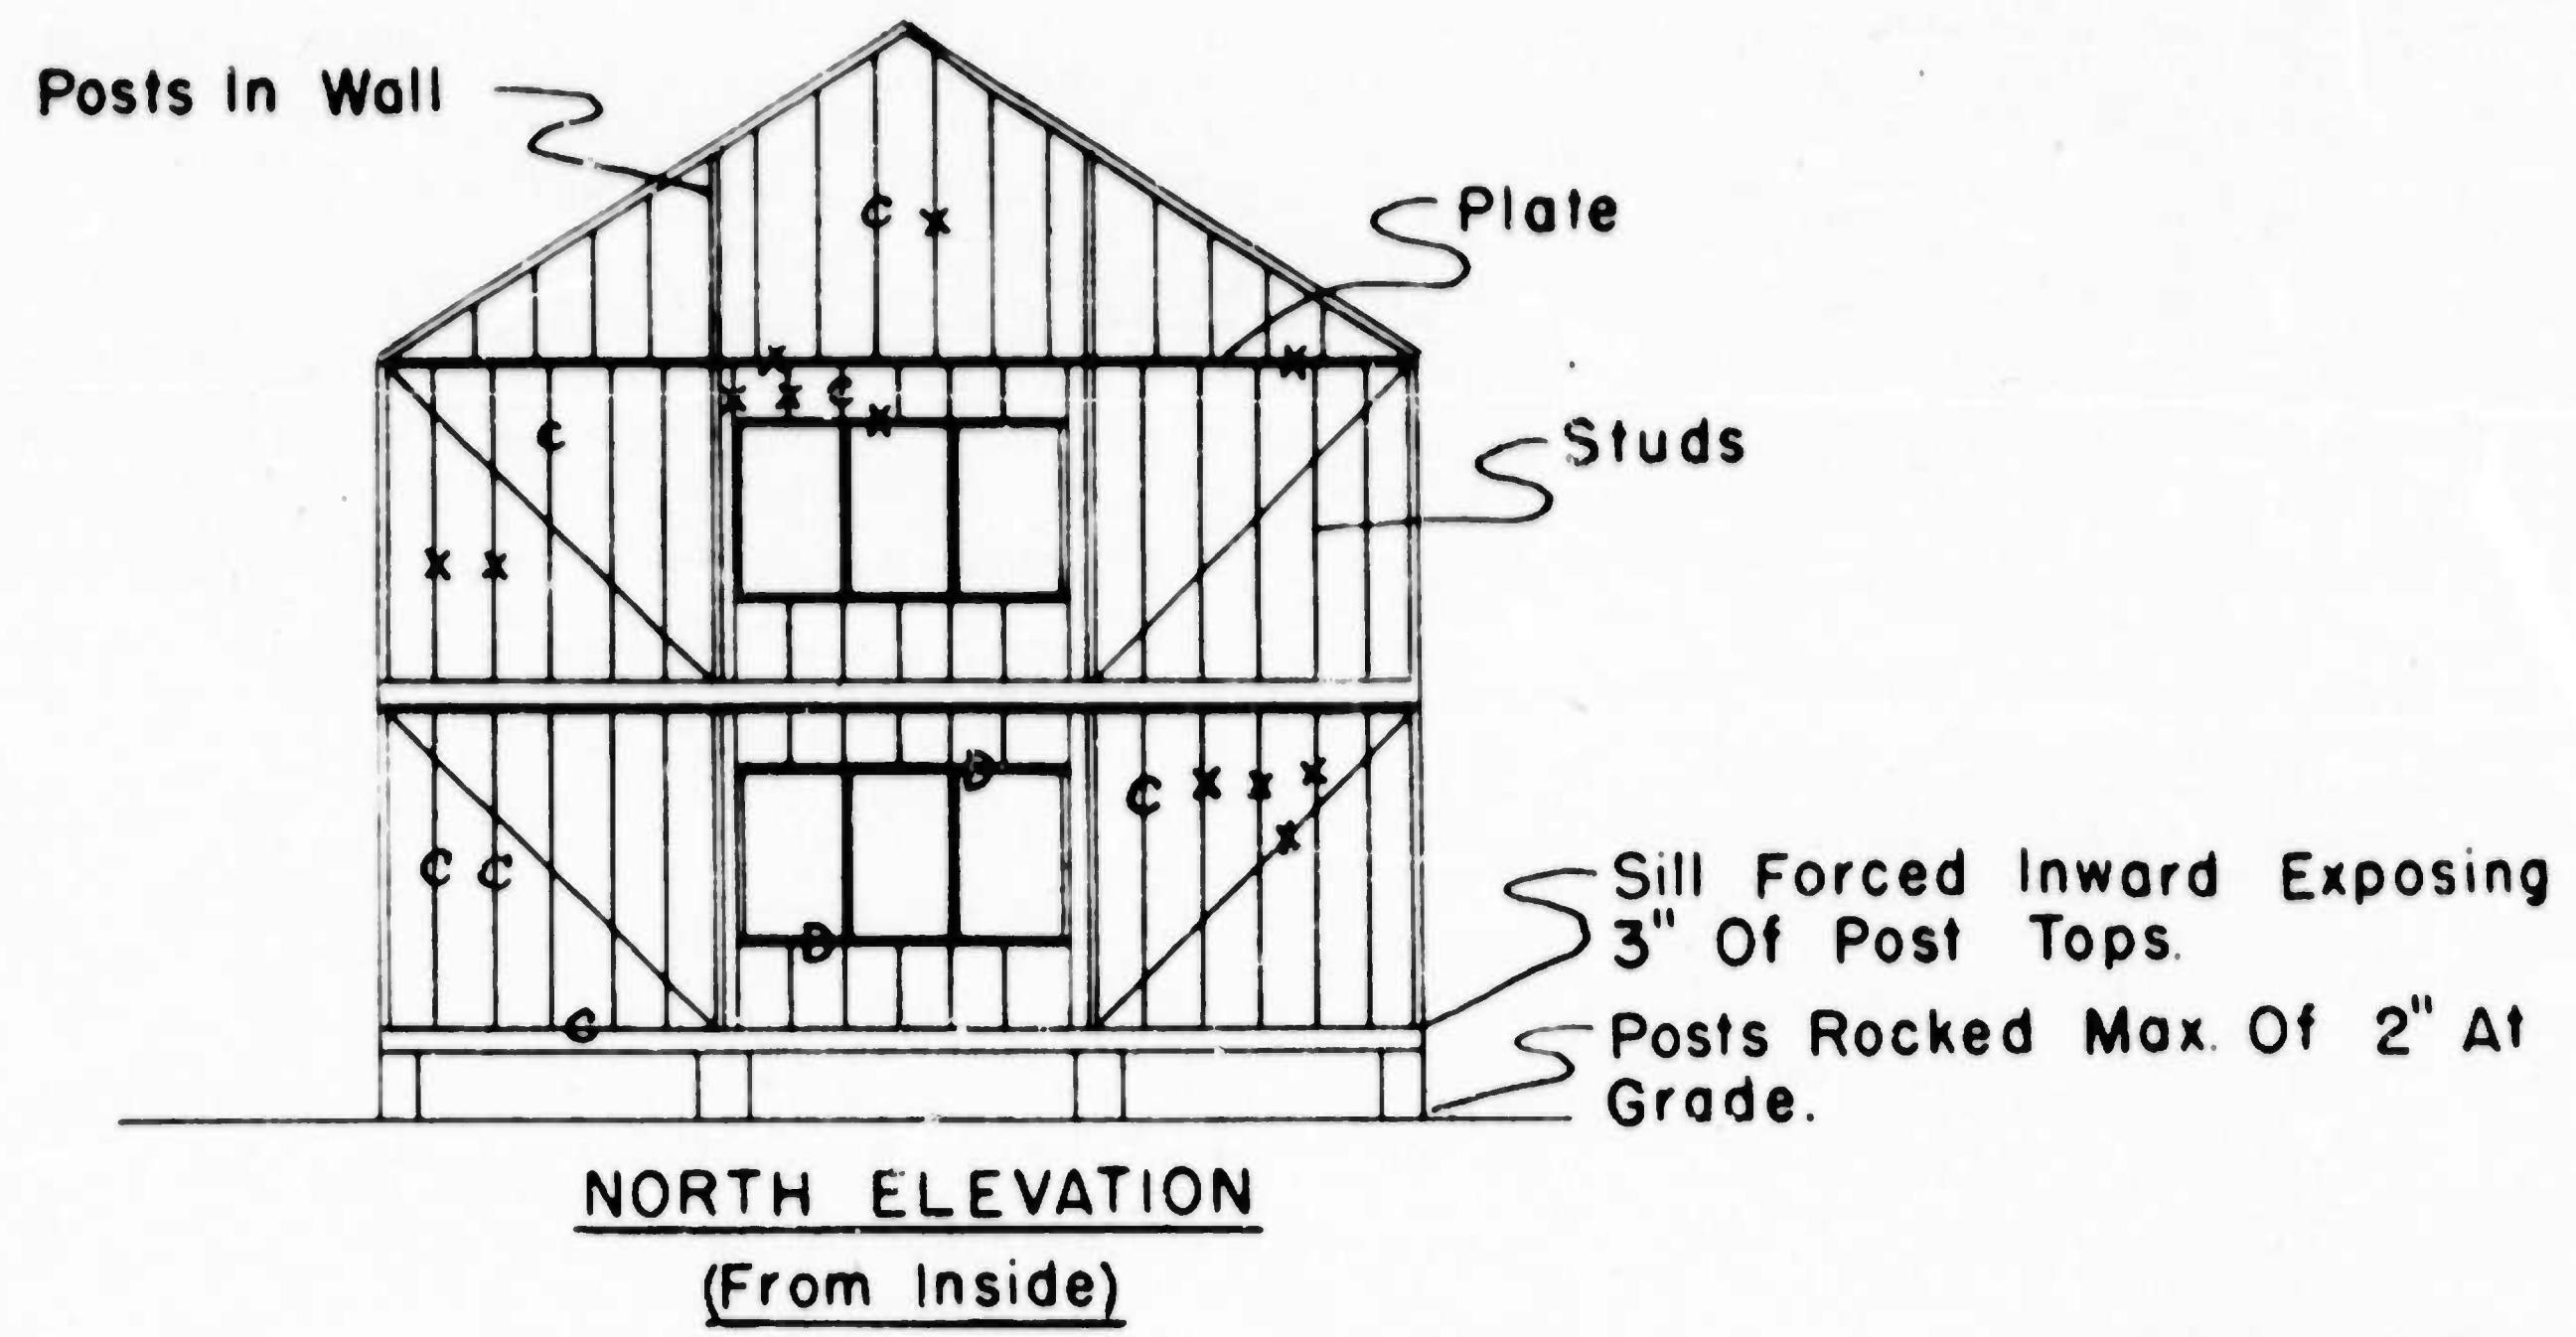
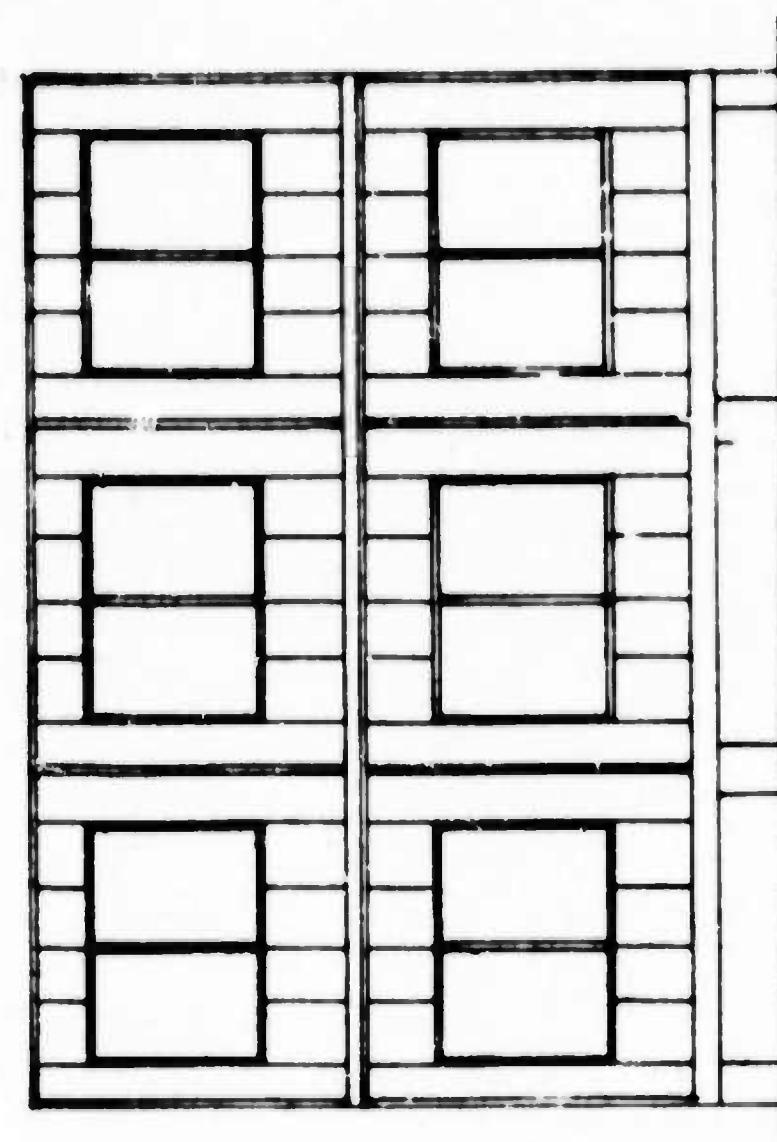
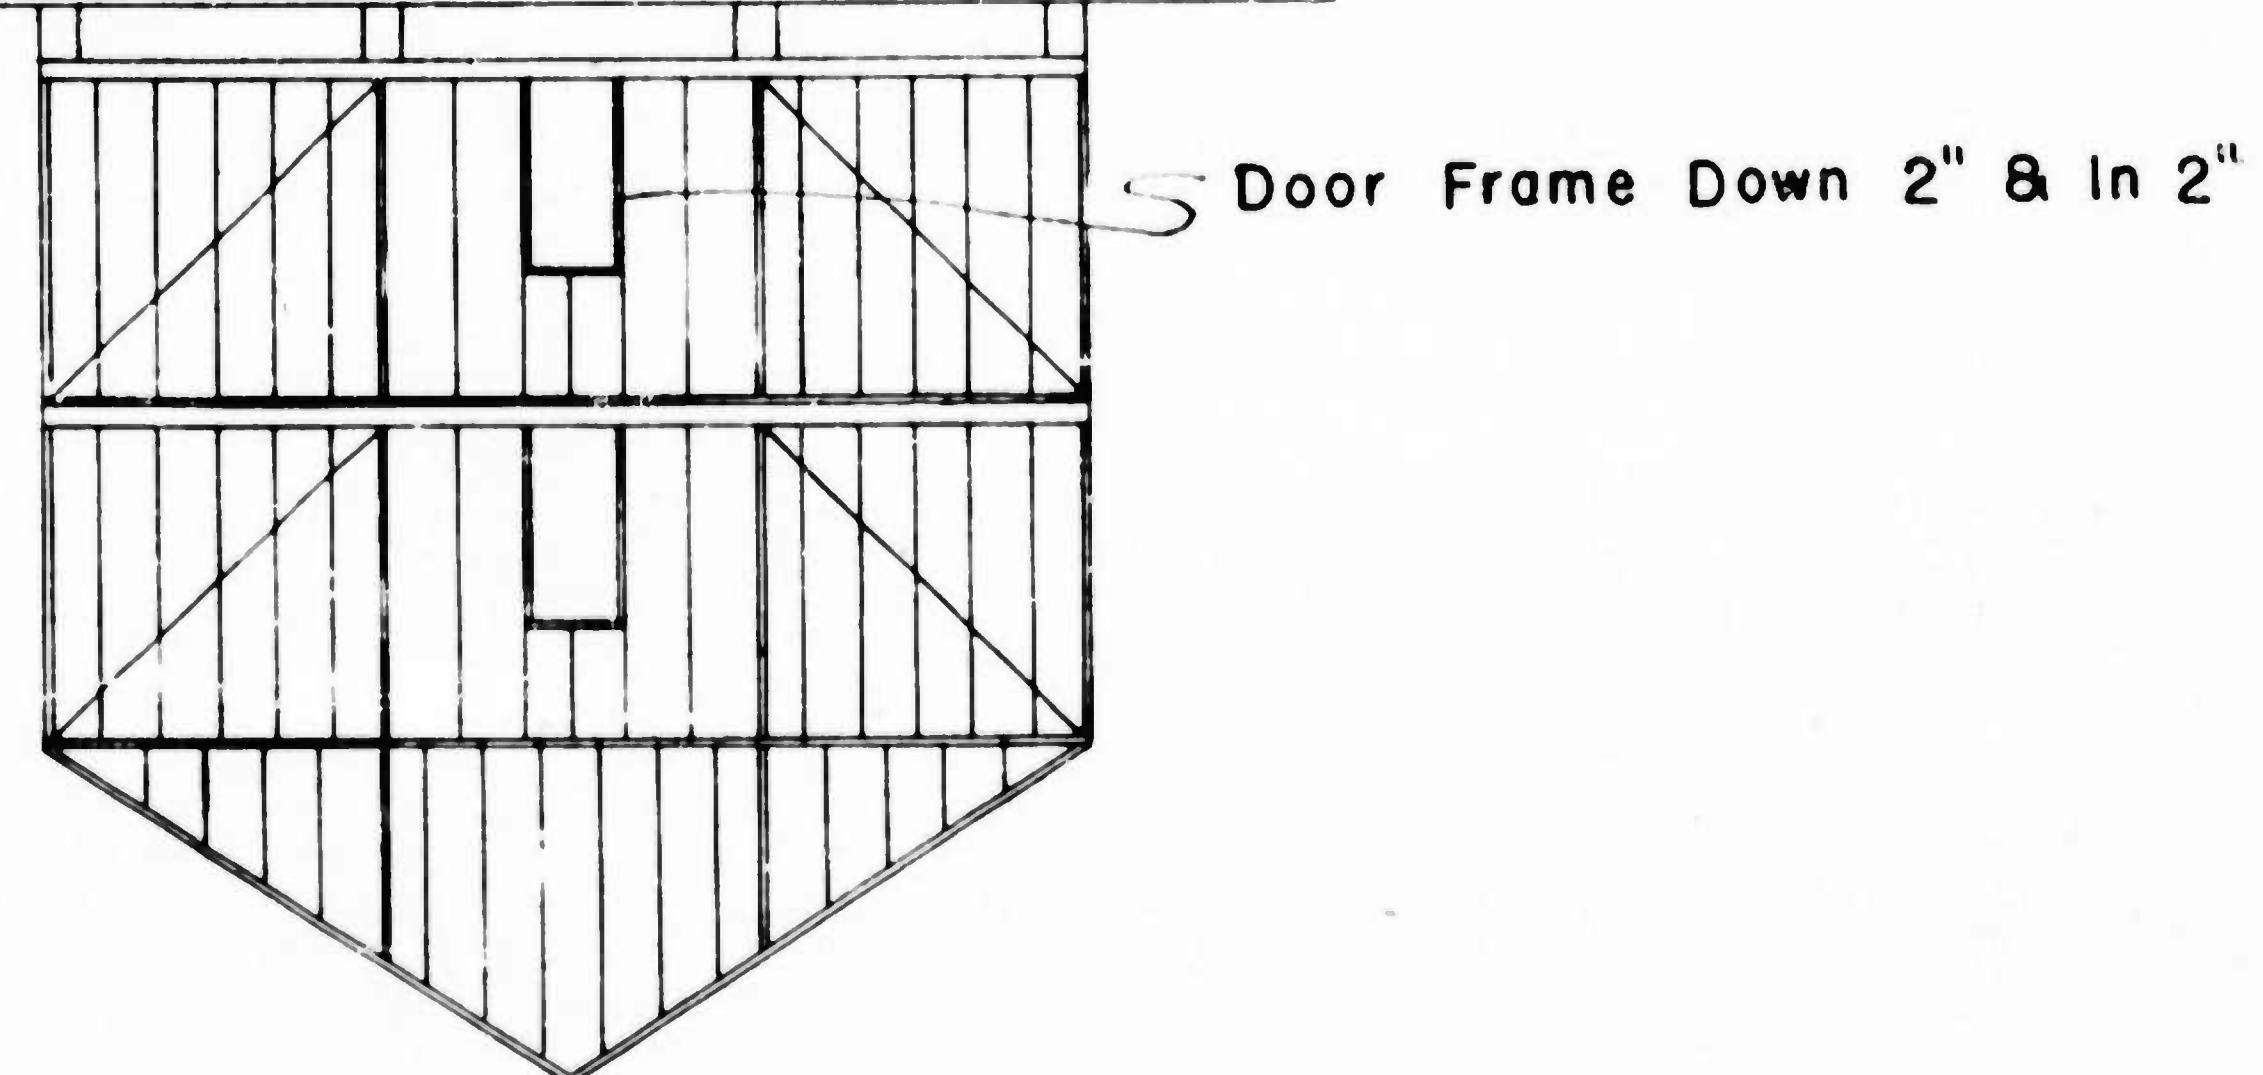
FIGURE 128. Damage to Barracks, Barracks 2, Test 2

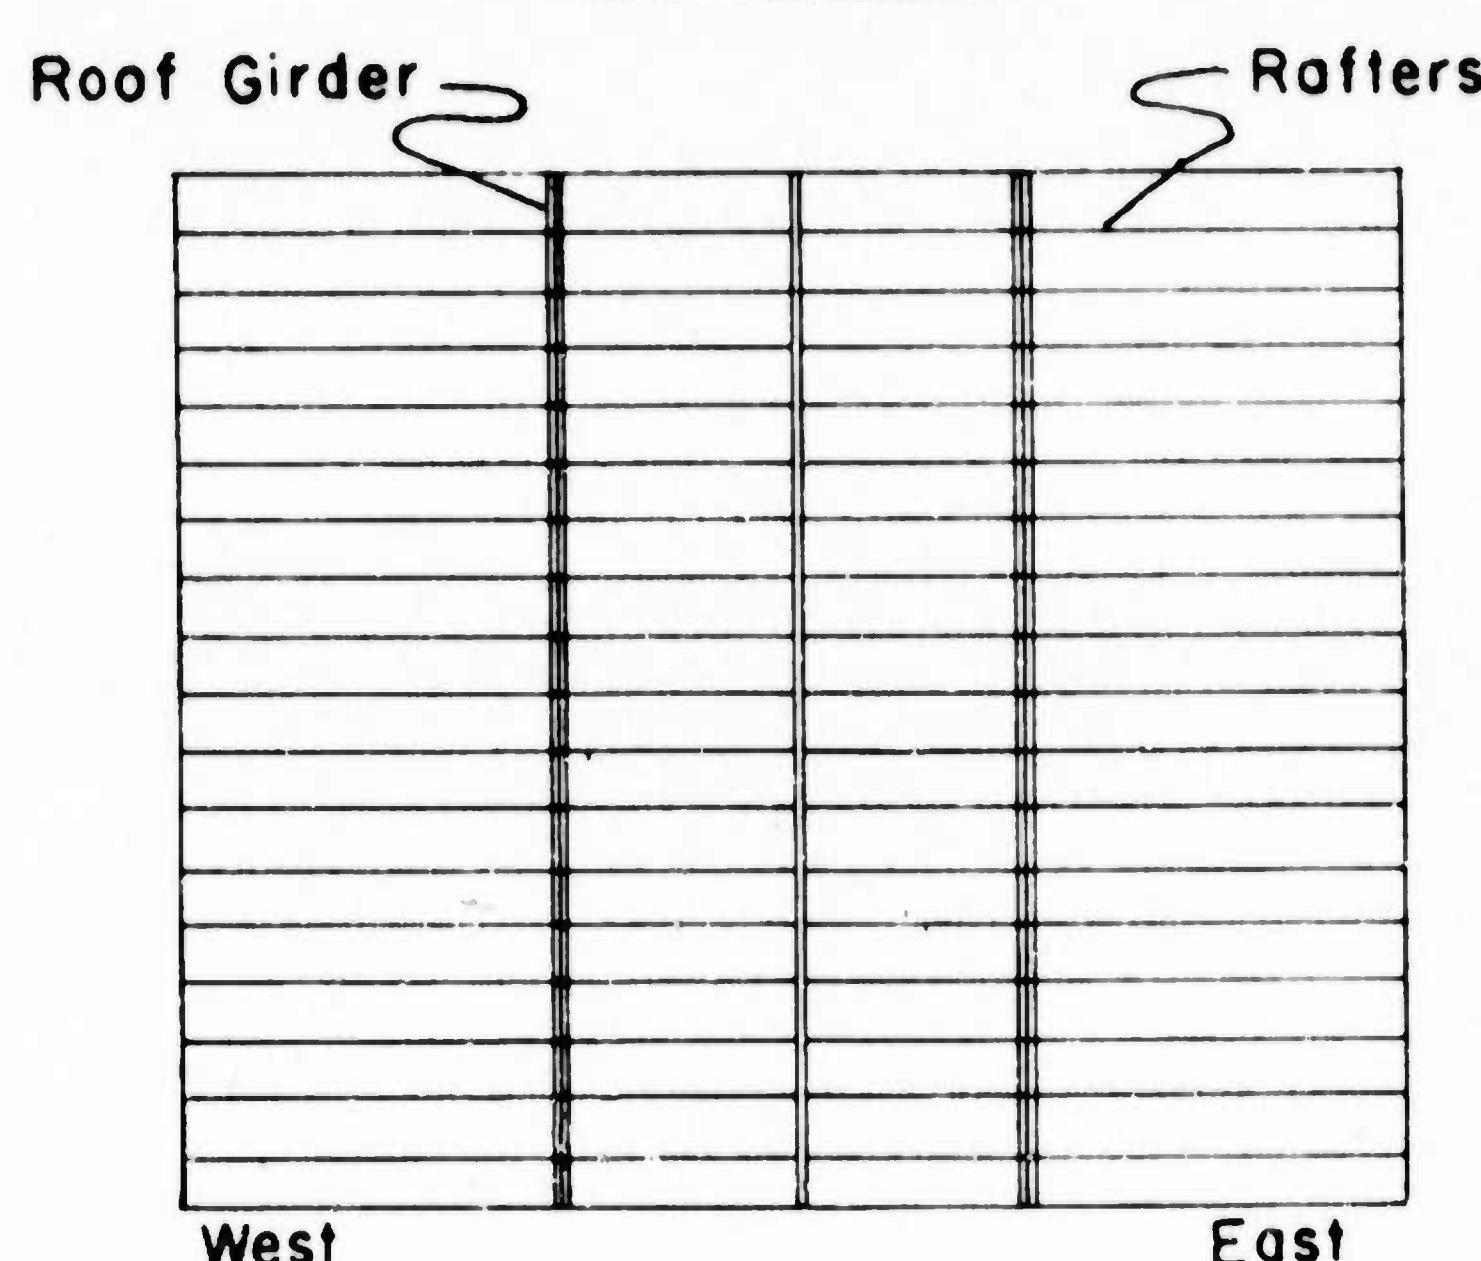
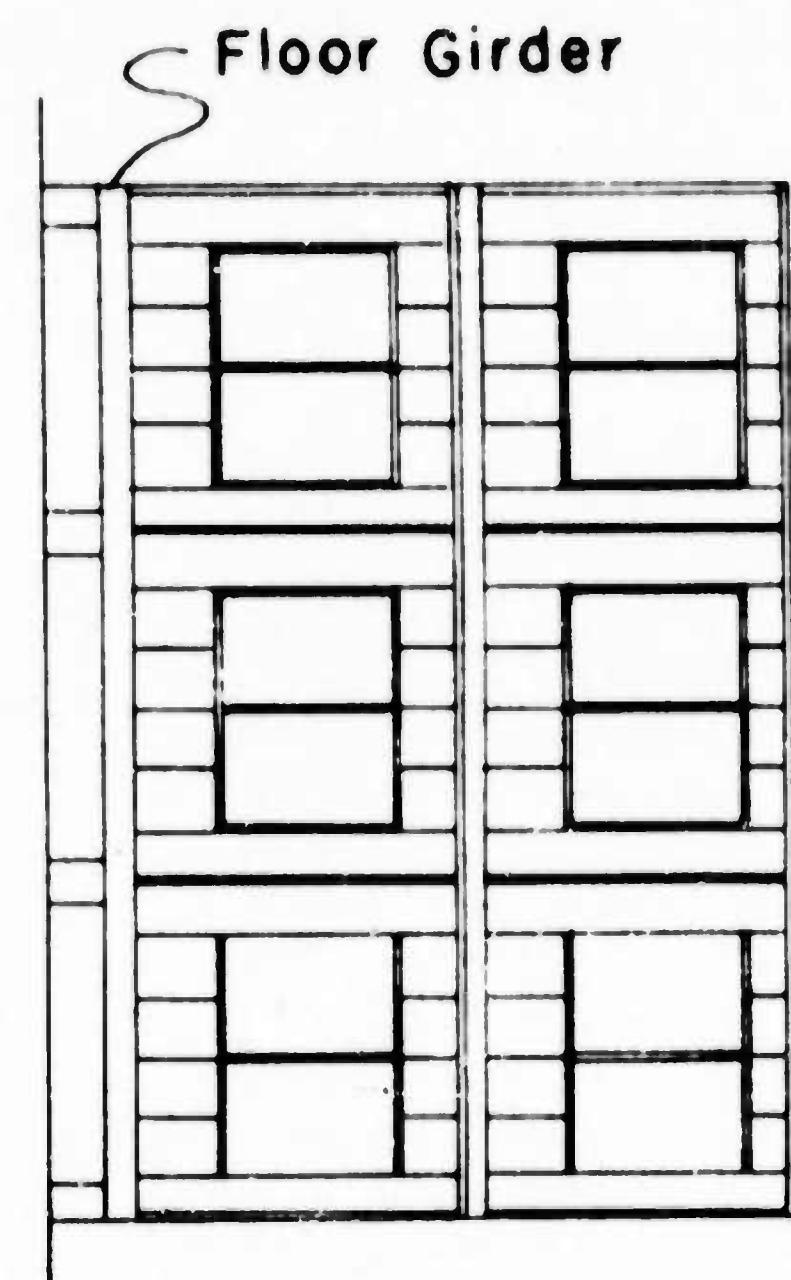
Barracks 2 was also rocked on its foundation posts, leaving crevices between the earth and sides of the post 2 inches wide on the north, $\frac{1}{2}$ inch wide on the east, $1\frac{1}{2}$ inches wide on the south, and $\frac{1}{2}$ inch wide on the west sides. In addition, the stringer bearing on the exterior line of posts was pushed inward, exposing parts of the tops of the posts, and carrying the wall with it. This deflection amounted to 3 inches on the north side, 2 inches on the east side, and $1\frac{1}{2}$ inches on the west side. In the north wall on the ground floor, studding that had been cracked or loosened in the first blast was more seriously broken and separated farther from the plates and sheathing. In the second story, previously broken studs, plates, and sheathing were deflected farther inward. Damage in the gable wall was similarly increased. There was no appreciable increase in structural damage to the remainder of the building. Figures 123 through 127 illustrate typical cases of failure and displacement of interior members, and figure 128 shows the damage to the building in diagrammatic form.

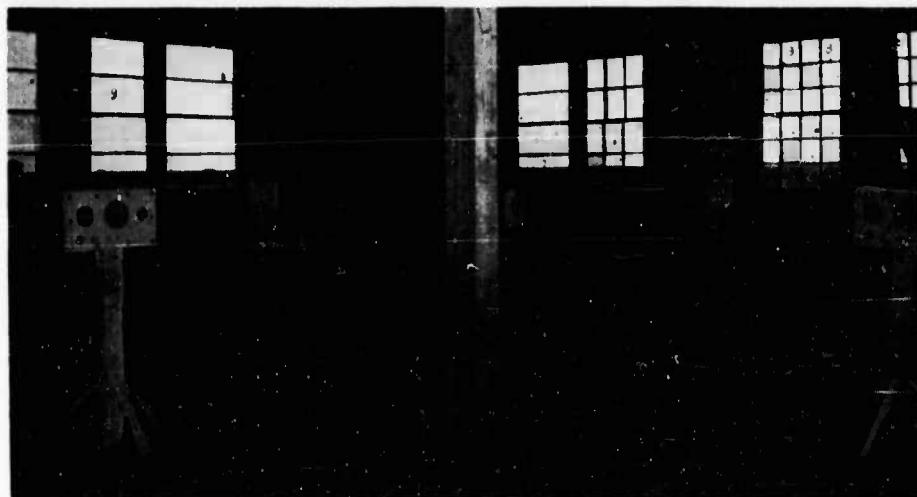
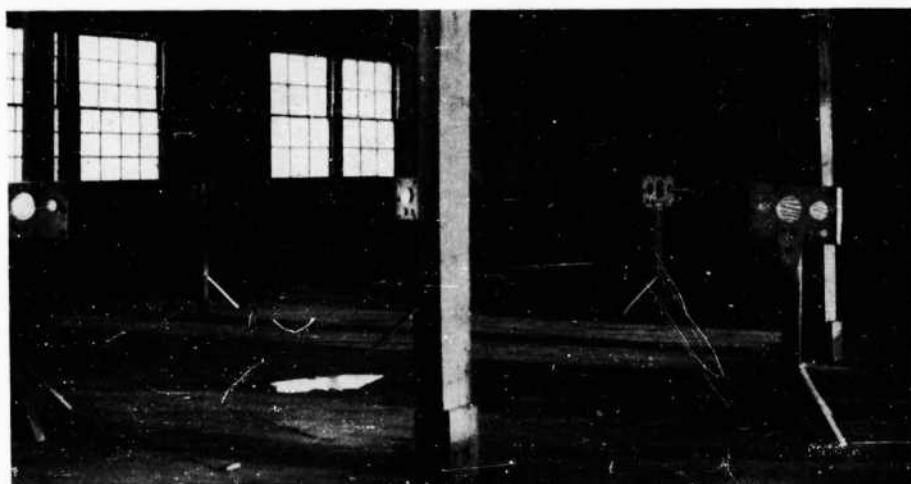
Barracks 3 sustained one additional broken stud in the north wall on each story, but no other structural damage. Figures 129 and 130 show the appearance of the interior of each story after the second test.

FIGURE 129. Interior of lower story, looking northeast, Barracks 3 after Test 2

FIGURE 130. Interior of upper story, looking southeast, Barracks 3 after Test 2

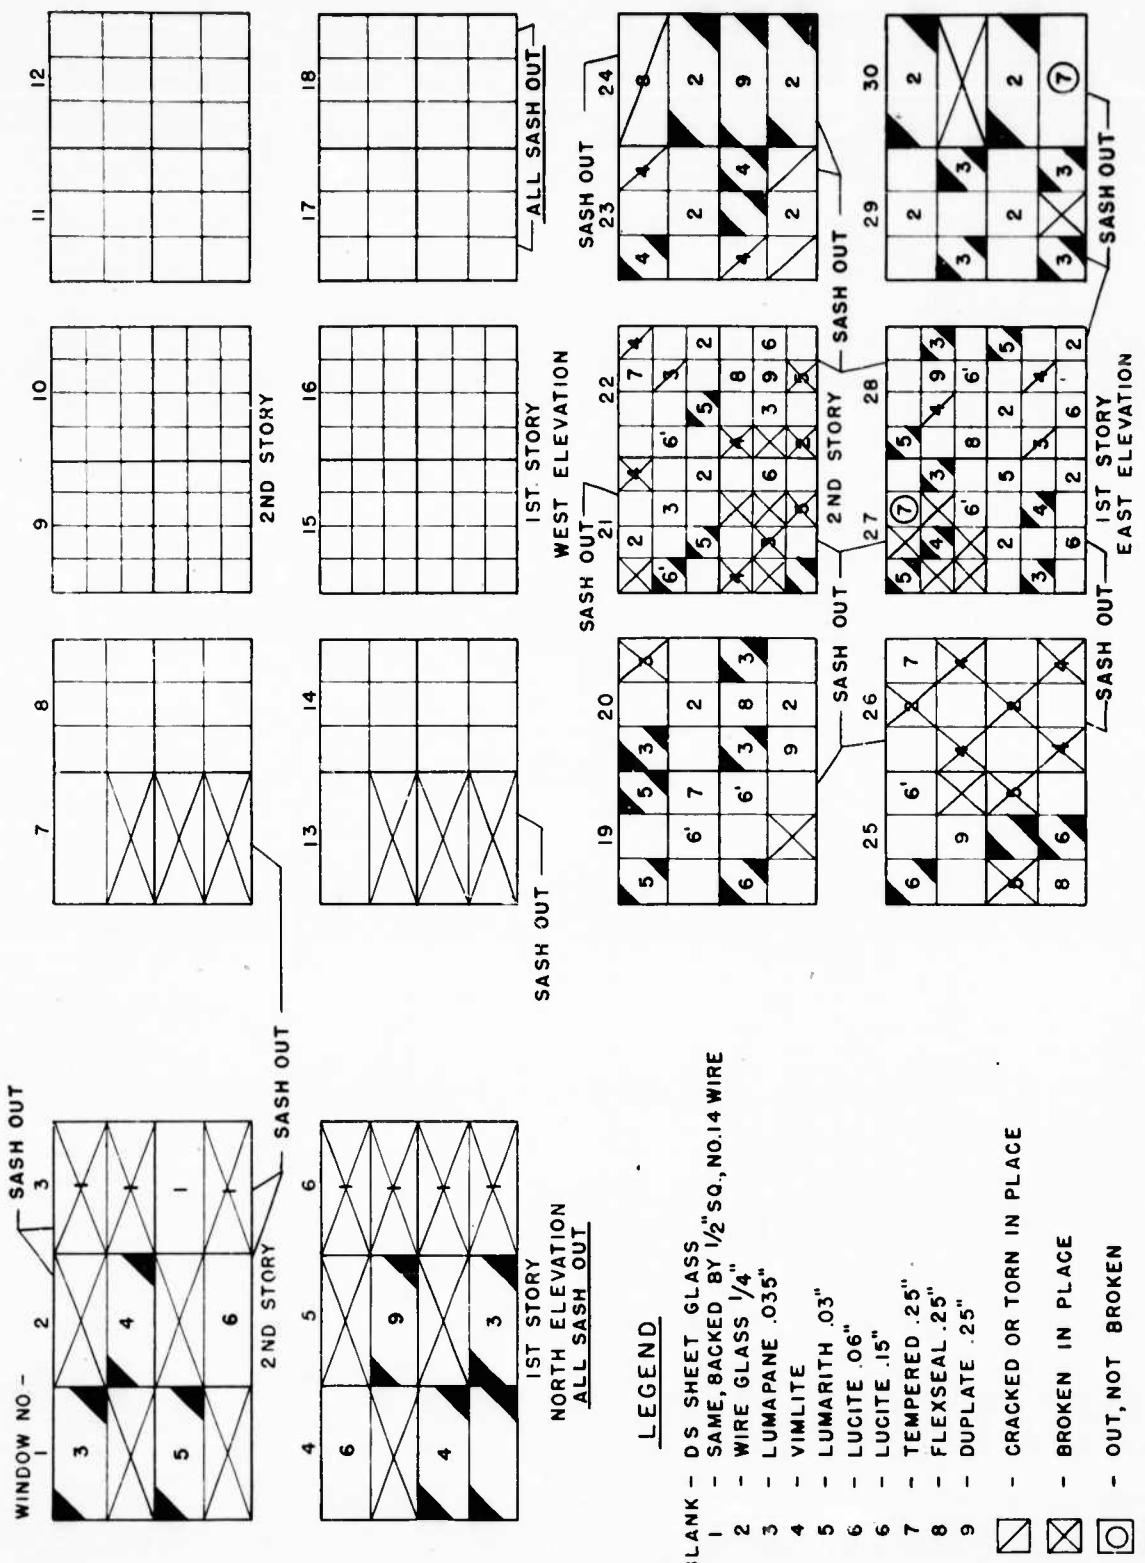
FIGURE 131. Glass Damage, Barracks 1, Test 2

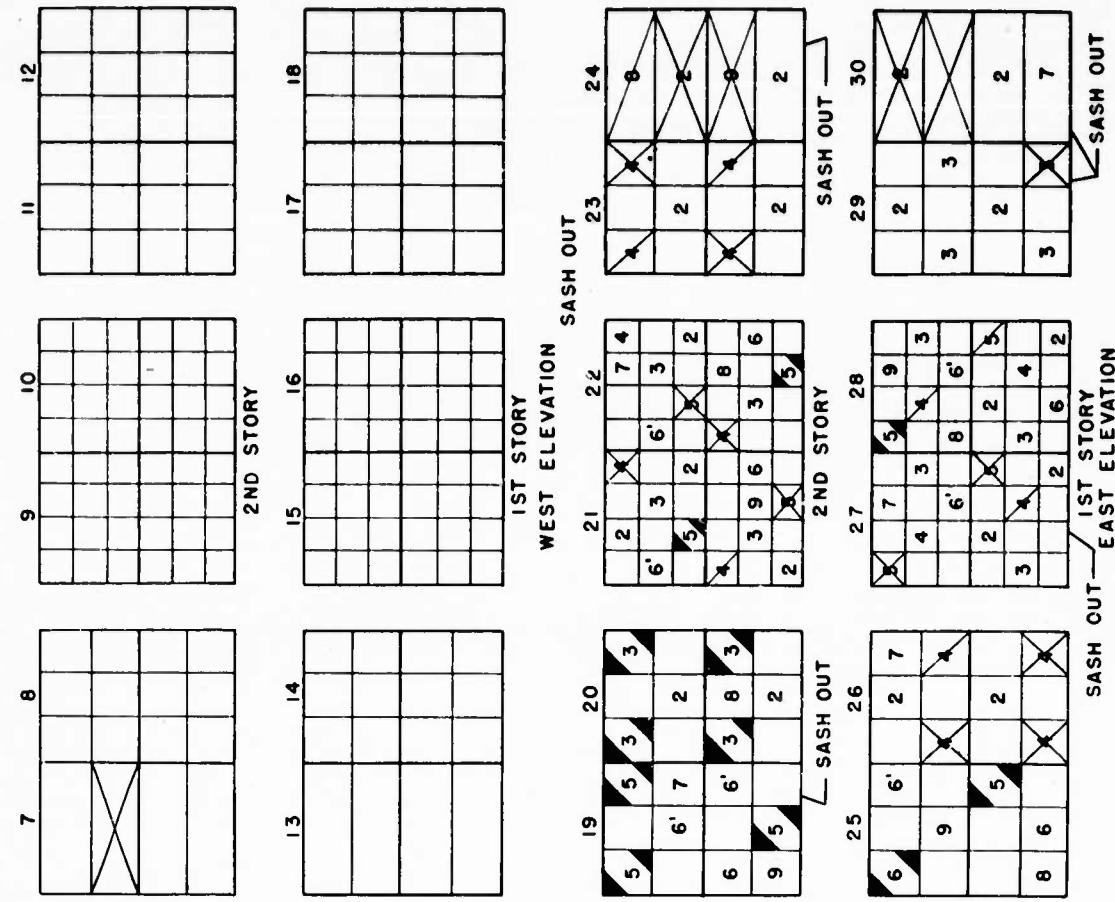
FIGURE 132. Glass Damage, Barracks 2, Test 2

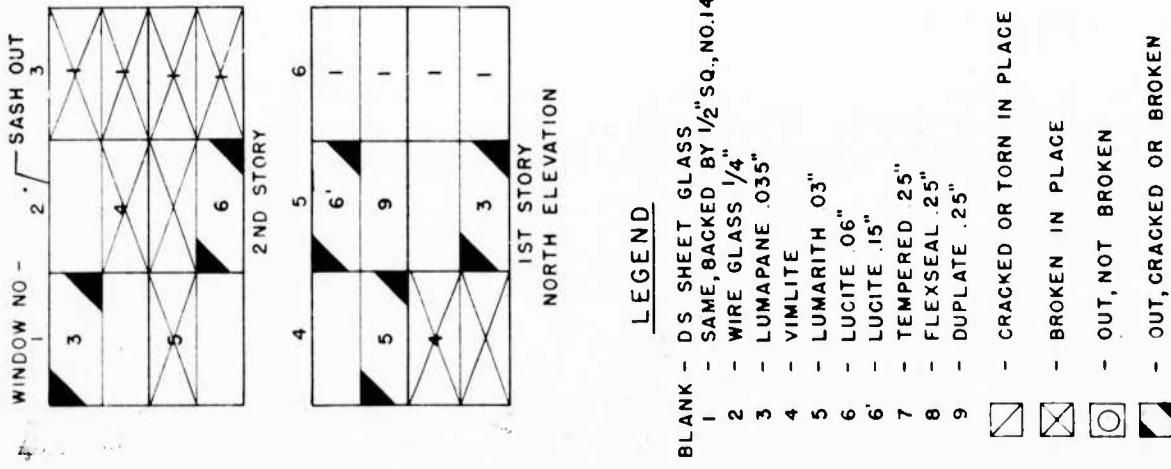
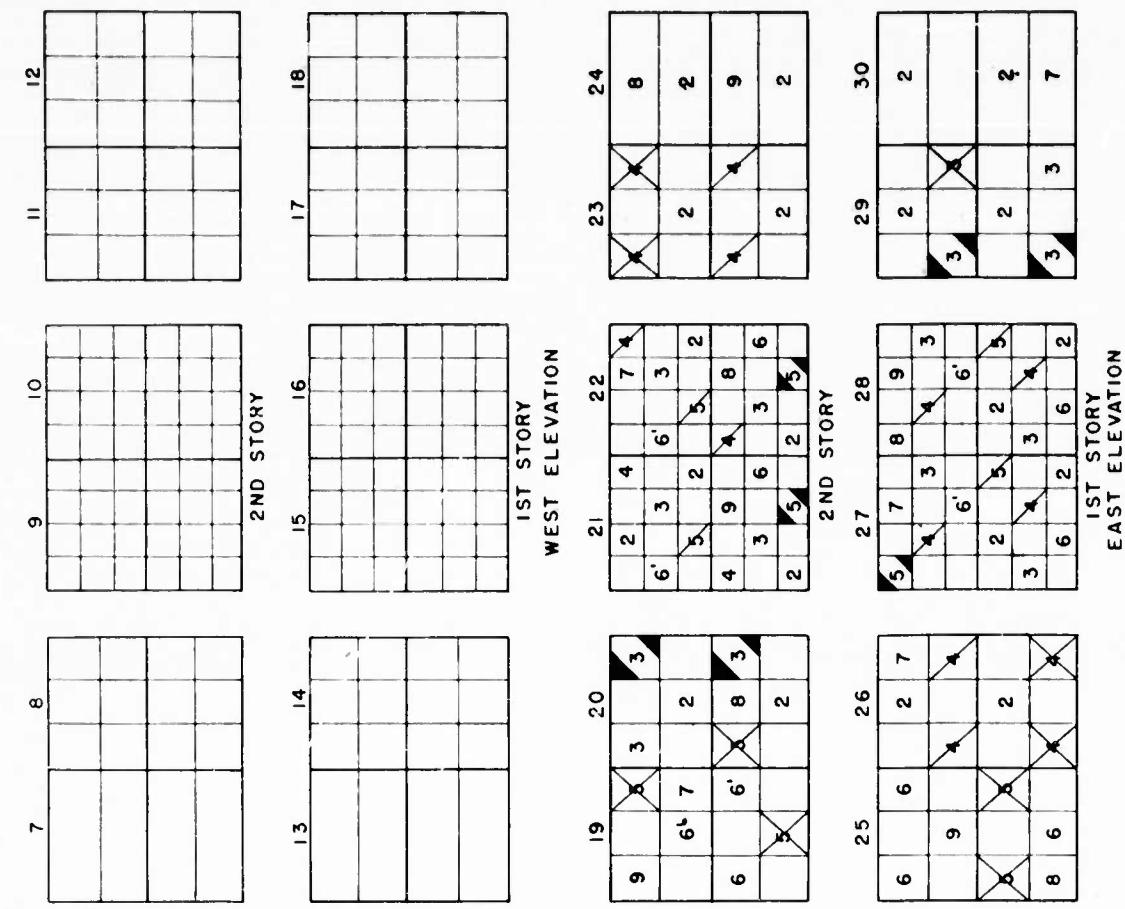
FIGURE 132. Glass Damage, Barracks 3, Test 2

Barracks 3.—On the north elevation, four panes of DS glass backed by wire mesh and one with no backing were demolished in place. On the east side, three $11\frac{5}{8}$ " x $14\frac{3}{4}$ " pieces and two $8\frac{5}{8}$ " x $9-11/16$ " pieces of Vimlite were either torn loose, left hanging, or were completely missing. One light of Lumapane $11\frac{5}{8}$ " x $14\frac{3}{4}$ " in size and one small pane of the same material were blown in. Figure 133 gives the total glass damage to this building following test 2.

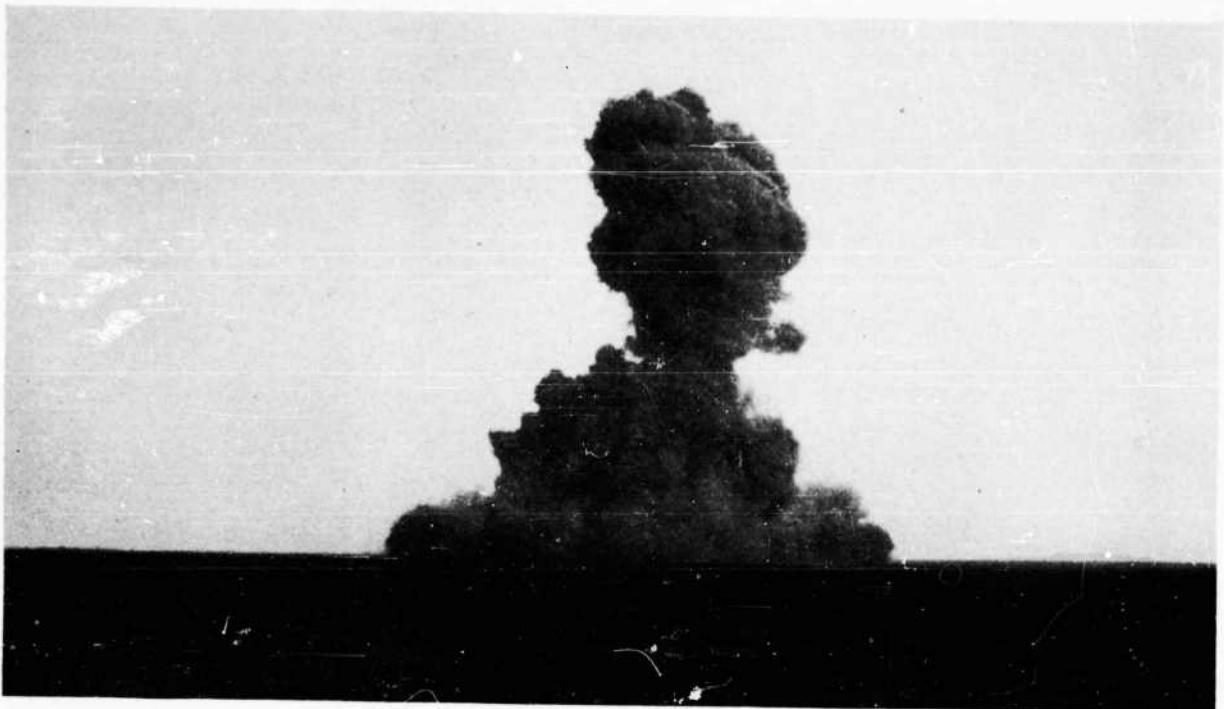
FIGURE 139. Explosion of Igloo F, 3rd stage

of the base seems to be at least doubled. Figure 139 is a good illustration of this.

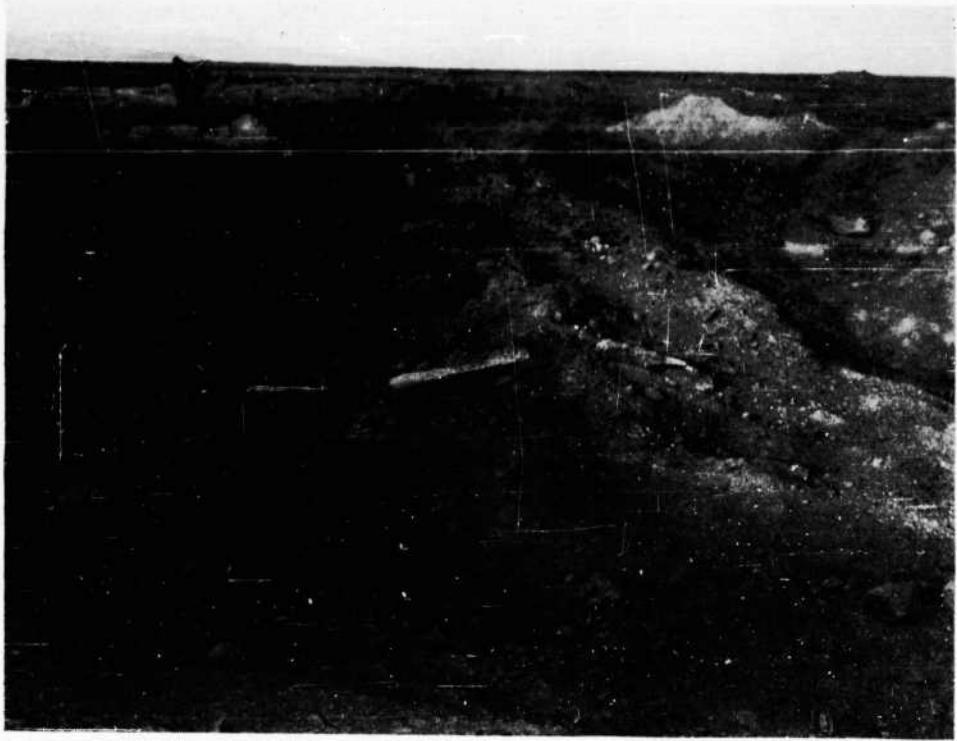
(d) *Crater*.—The crater was approximately round, with an average apparent diameter of 137 feet and a maximum apparent depth of 9 feet. While roughly symmetrical with respect to the longitudinal axis, it was quite eccentric with respect to the original lateral axis through the center of the igloo, the south radius being 87 feet while the north radius was only 48 feet. Thus the crater's center was 36 feet south of its normal position. Apparently the expanding explosion gases excavated more soil under the heavily earth covered portion of the igloo than near the uncovered front end. The bottom of the crater was peculiar in that the deeply excavated portion was shaped like a horseshoe, with the open end pointing north. A ridge of ground extended southward from where the

FIGURE 145. Crater of Igloo F, looking north from south rim

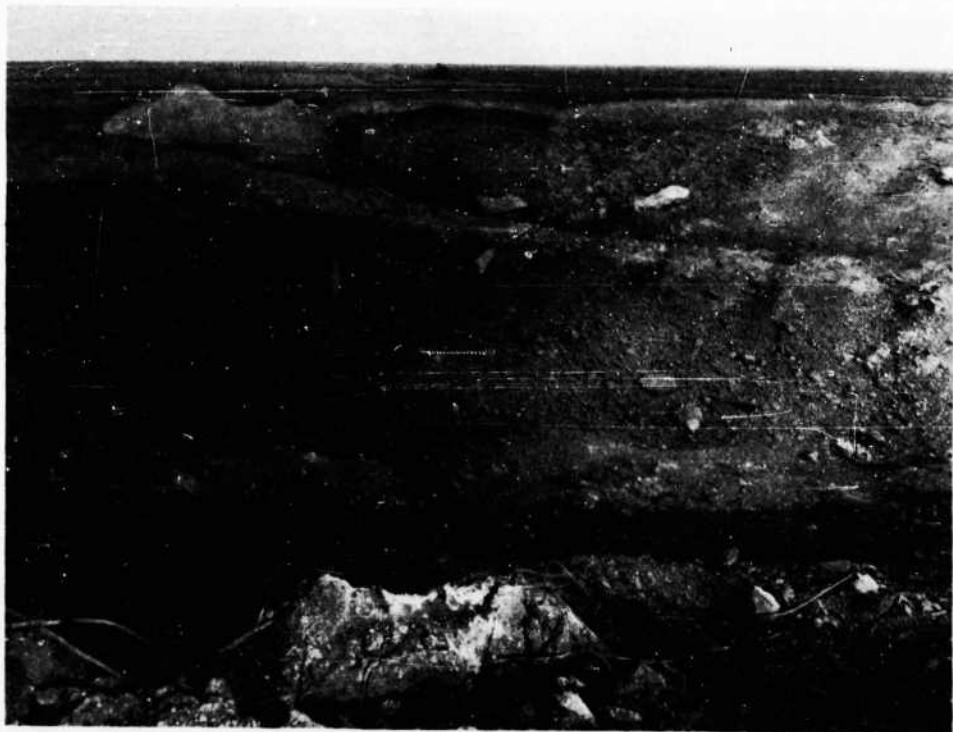
FIGURE 146. Crater of Igloo F, looking northeast from west rim

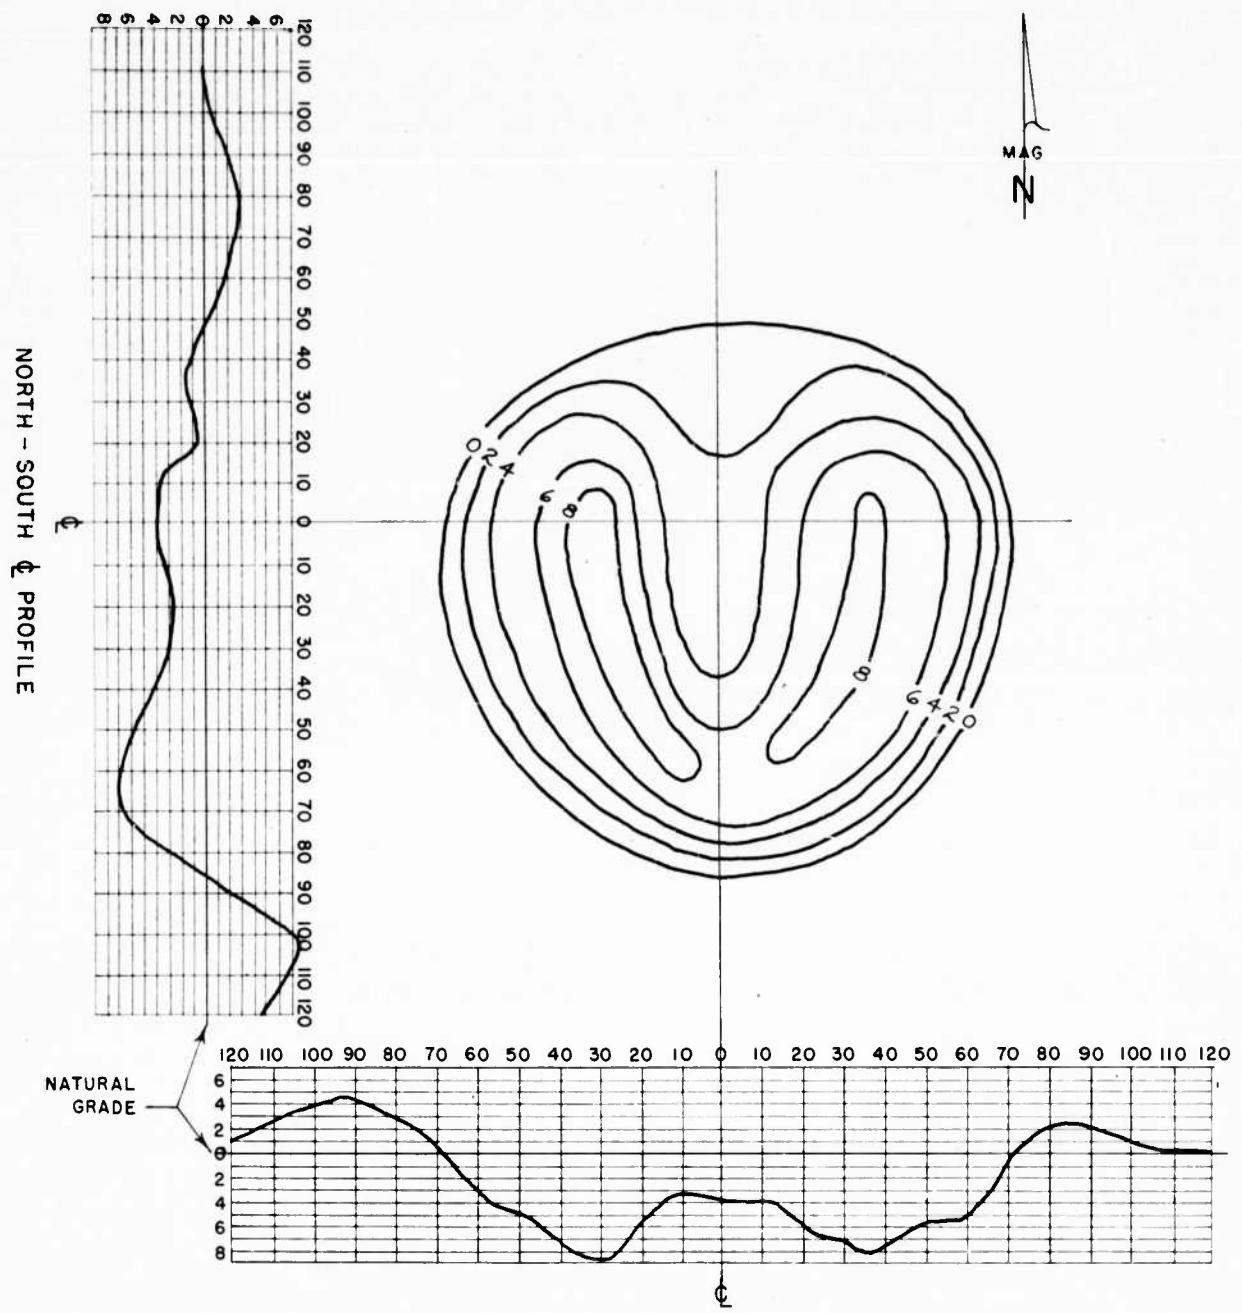
FIGURE 147. Crater Plan and Profiles, Test 3

Figure 147 gives the profiles of this crater along the north-south and east-west axes.

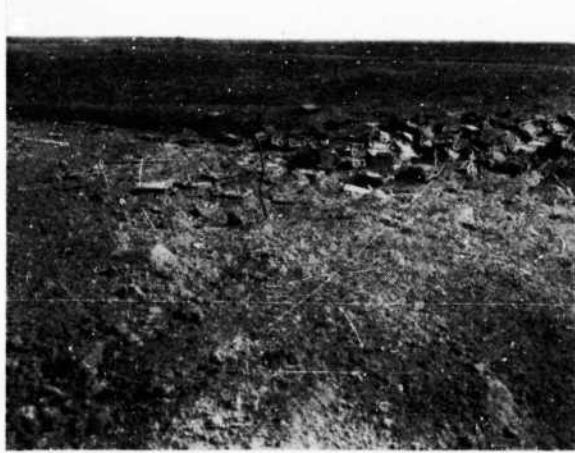
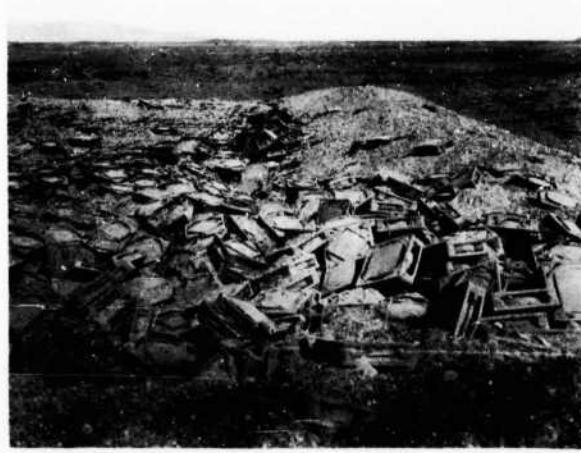
(2) *Revetment 2*.—These mines had also been restacked before the third test. As a result of the explosion under heavily increased earth cover, the revetment was deluged with earth and the mines were badly shaken and scattered about. Many crates were broken open, mines dented, and a number of loose activators were found on the ground at one point on the east side of the revetment. Most of the

scattered mines were blown away rather than toward the explosion as in previous tests. Mines found lying on and beyond the far windrow numbered about 150. The space between the near side of the mine stack and the near windrow was filled with earth to within one or two feet of the top of the stack. Earth was up to 2 feet thick on top of the near side of the stack, and the entire stack was covered so that no mines could be seen except near the far edge. Three pieces of reinforcing steel rod were found protruding from the top of the stack. Fragments of concrete, wire mesh, and other debris were abundant in the earth covering the mines. Figure 149 is a view looking eastward across the top of the half-buried pile from the west (near) side. Figure 150 shows the east edge of the stack as viewed from the southeast corner. In the foreground may be seen a large number of scattered mines.

FIGURE 149. Revetment 2 after Test 3, looking east from west side

FIGURE 150. Revetment 2 after Test 3, looking north from southeast corner

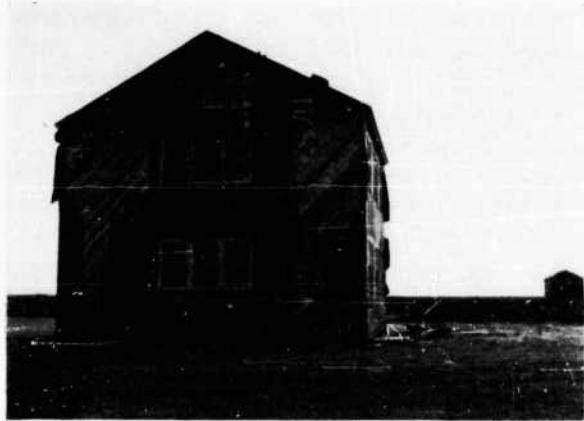
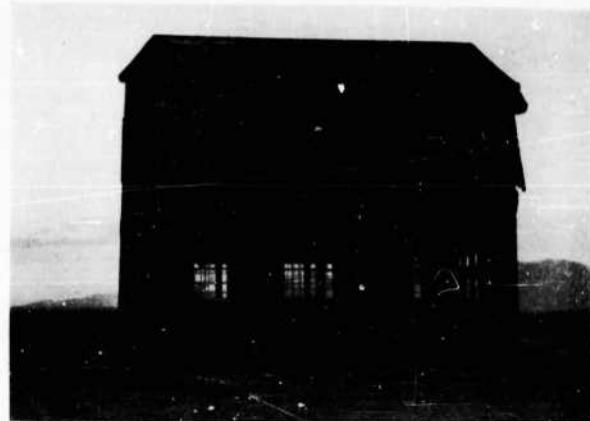
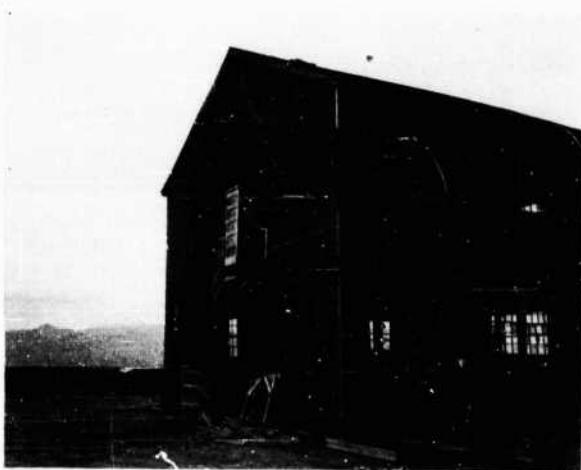
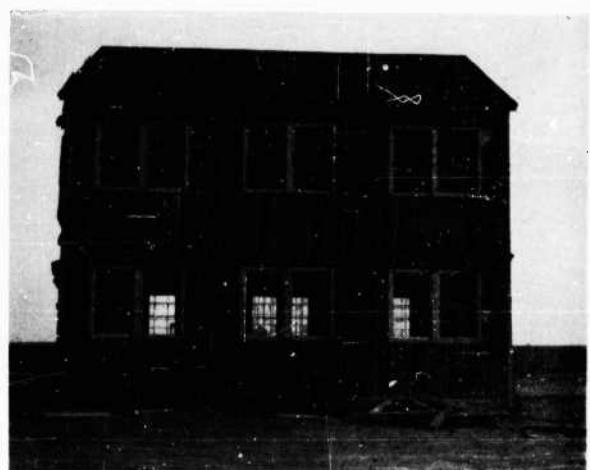
(g) *Damage to barracks*: (1) *Superficial*.—Barracks 1 had been repaired before test 3, except for torn siding which was merely tacked back in place, and except for roofing. Broken window sash, frames, and trim were completely renewed. See figures 151–154 for views of the building after the explosion of Igloo F. The north end of the building lost all previously torn areas as well as additional areas of asphalt felt siding and the battens which covered it, to the extent that about one-half of the sheathing was laid bare. One lower sash was blown into the building. On the east elevation, one sash was blown into the building, two were blown

FIGURE 151. North elevation of Barracks 1 after Test 3

FIGURE 152. East elevation of Barracks 1 after Test 3

FIGURE 153. Three-quarter view: south and east sides of Barracks 1 after Test 3

FIGURE 154. West elevation of Barracks 1 after Test 3

out, and two others were demolished in place. On the south side, siding and battens were blasted off in several places. The west elevation lost siding alongside upper and lower story windows at the south end of the building. On the east slope of the roof, the previously torn spot did not seem to have been made any larger.
